Manhole Inspection Summary

Manhole # S27I__017MH

Insp Date: **1/22/09 10:02 AM**

Location Address: **Boyd St.**

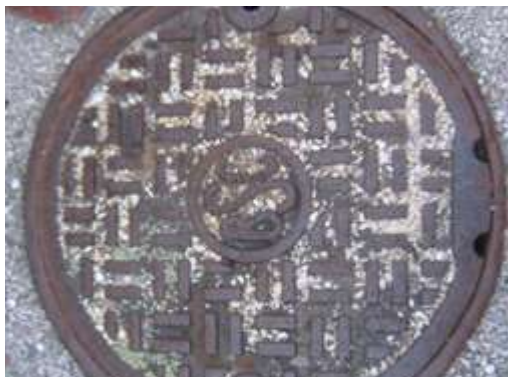
Miscellaneous

MH Lid

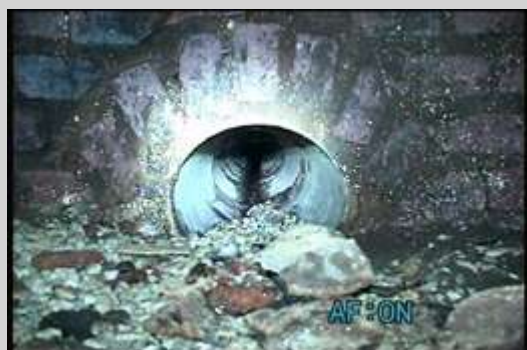
12 O'Clock Outflow

8 in. Circular Gravity Sewer
Pipe Out @ 12 O'Clock

Infiltration: **None** Pipe Seal Cond: **Sound**
